# **Navajo Abandoned Uranium Mine**

## **Site Screen Report**

### **Yazzie No. 105 AUM Site**

**January 2011**

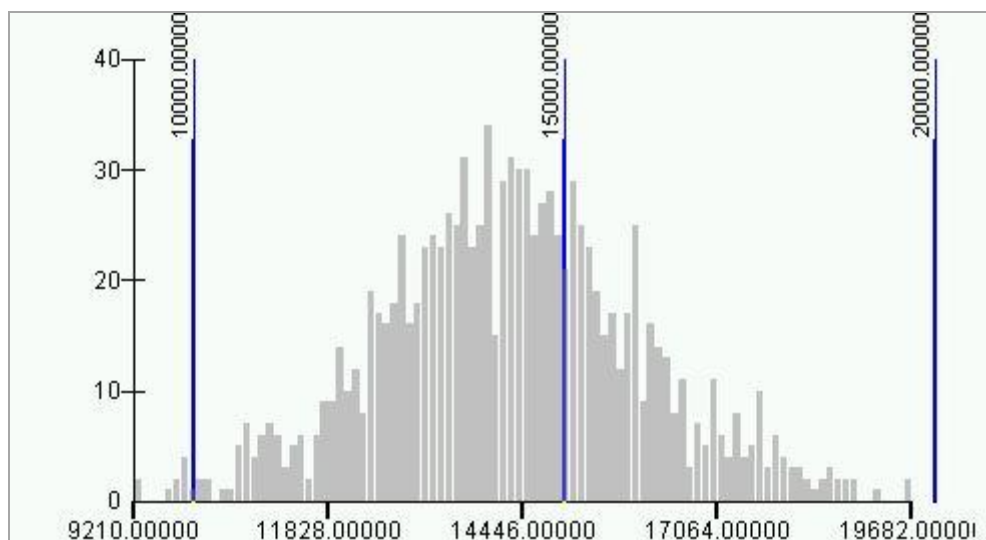
The following chart and statistics were generated by ESRI ArcGIS 9.3.1, and show the general distribution of the site gamma radiation measurements. The horizontal X axis represents the gamma radiation reading levels in cpm (lowest levels to the left). The vertical Y axis represents the frequency of each gamma radiation level.

Count:	1108
Minimum:	9210.00000
Maximum:	19682.00000
Sum:	15836315.00000
Mean:	14292.70307
Median:	14278.00000
Standard Deviation:	1754.20325

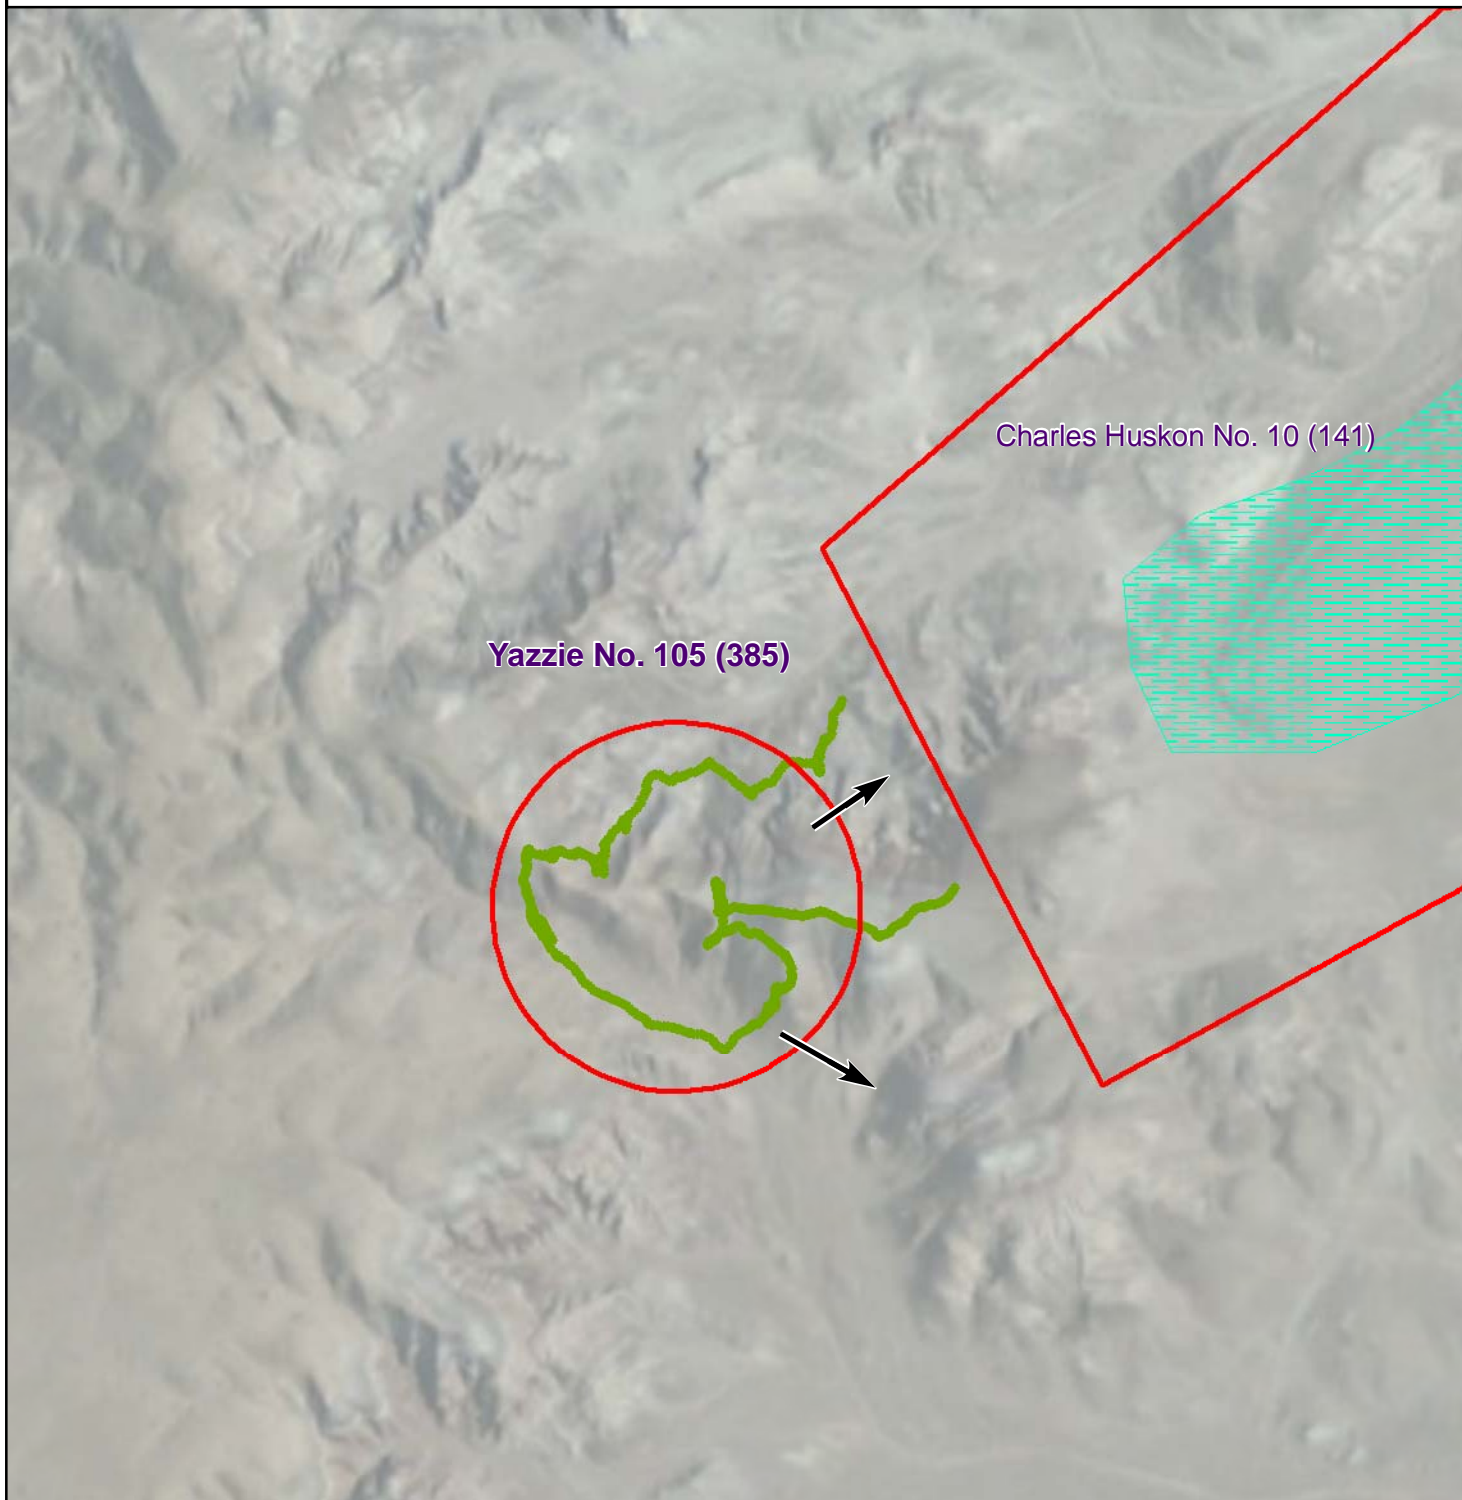
**Figure 1 - Gamma Radiation Measurements, Above Two Times Background  
Yazzie No. 105 (385)  
Cameron Chapter, Navajo Nation**

A total of 1,108 gamma radiation measurements were collected from the mine site, ranging from 9,210 cpm to 19,682 cpm. The measurements are represented in Figures 1 and 2.

Gamma survey conducted 11/2010  
Measured as counts per minute (cpm)

Average background 14,960 cpm

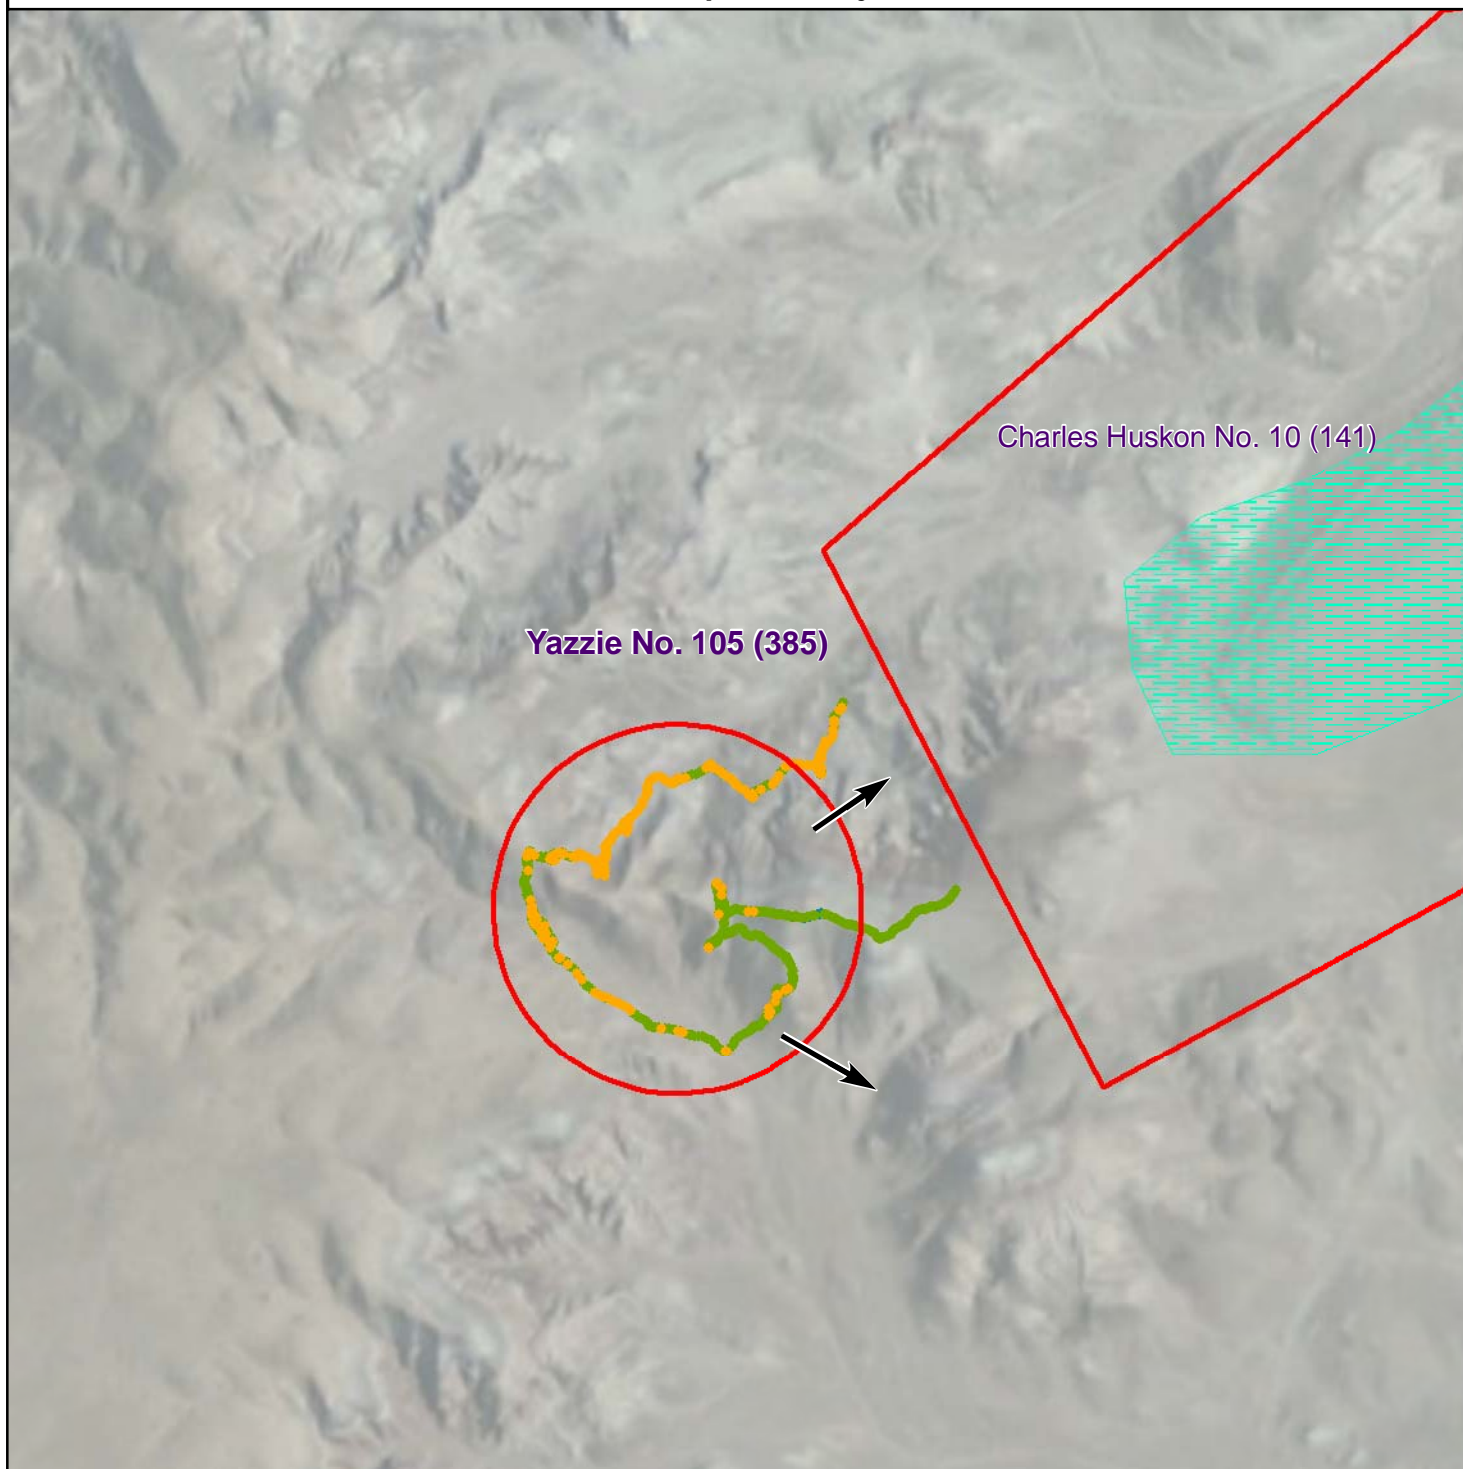
**Figure 2 - Gamma Radiation Measurements**  
**Yazzie No. 105 (385)**  
**Cameron Chapter, Navajo Nation**

**Gamma survey conducted 11/2010**  
**Measured as counts per minute (cpm)**

**Average background 14,960 cpm**
